Subj: Report of Independent Investigation of Major Aircraft Accident Involving  
LTJG Robert L. FISK, 594851/1315, USNR in F8U-1, BuNo 114433 on 3 April  
1958

REPORT OF INDEPENDENT INVESTIGATION

IN F8U-1, BU NO 144433

3 APRIL 1958

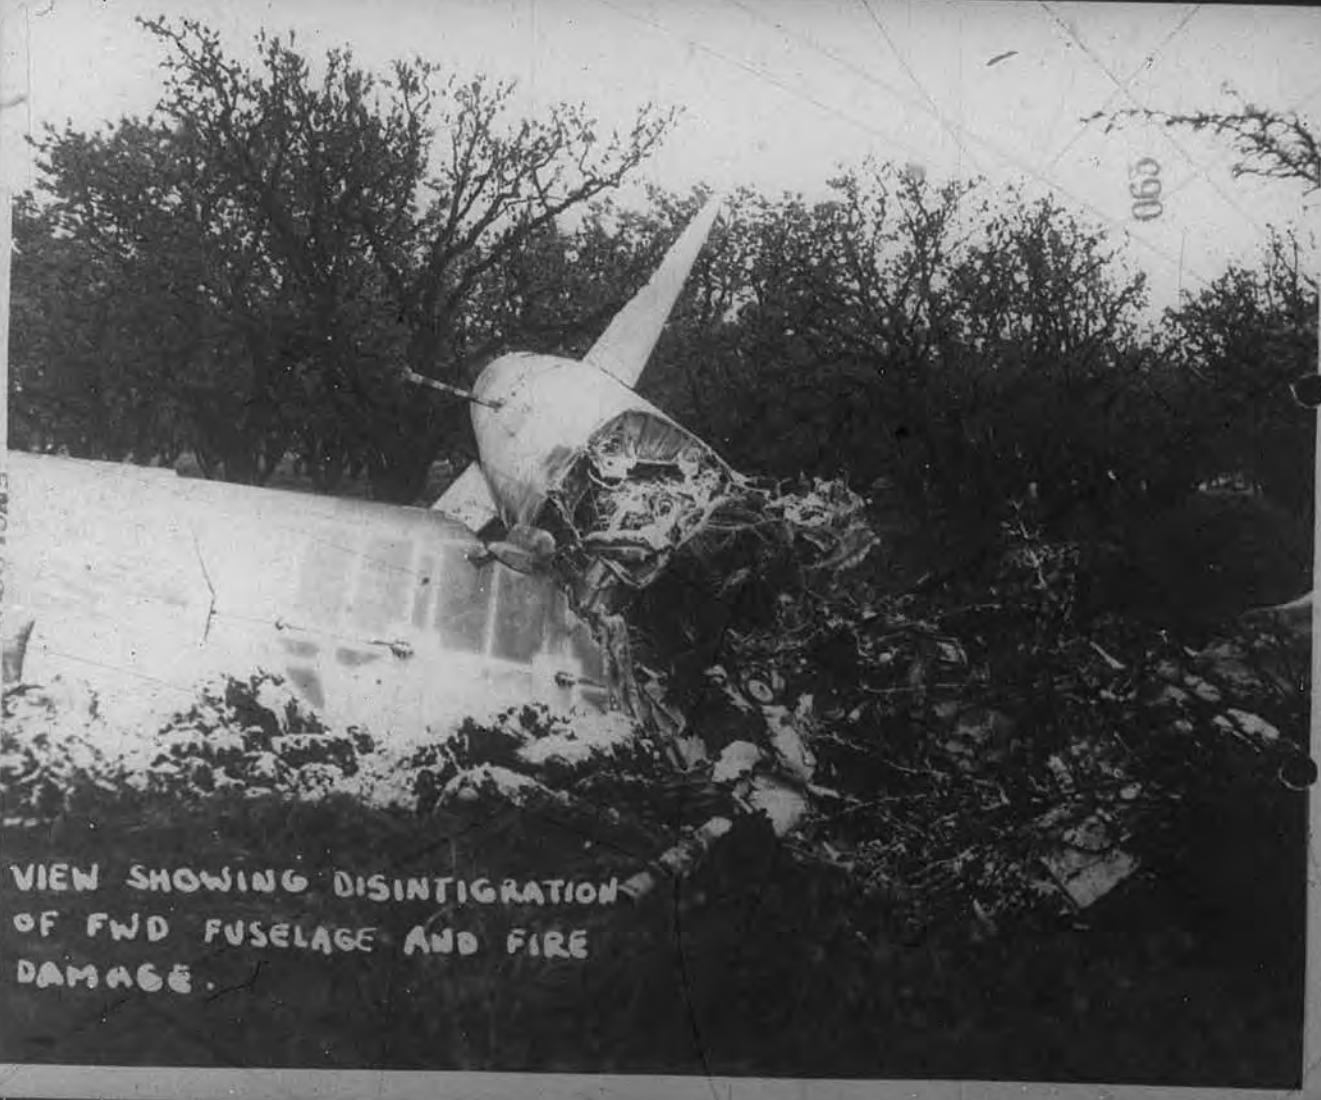
ENCLOSURE 3a

VIEW SHOWING DISINTIGATION  
OF FWD FUSELAGE AND FIRE  
DAMAGE.

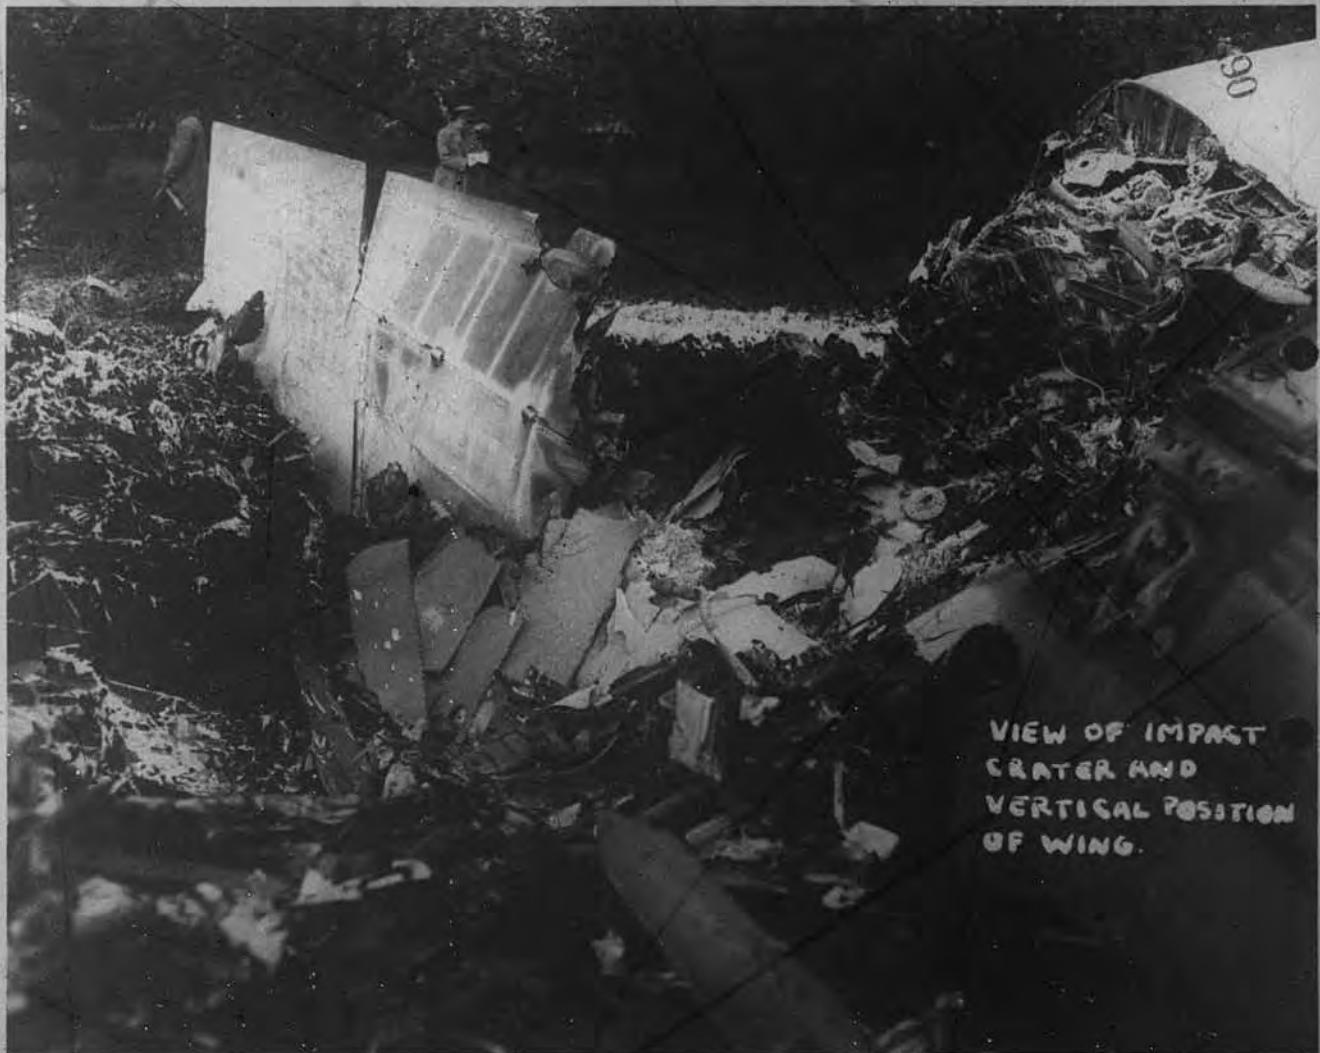
VIEW OF IMPACT  
CRATER AND  
VERTICAL POSITION  
OF WING.

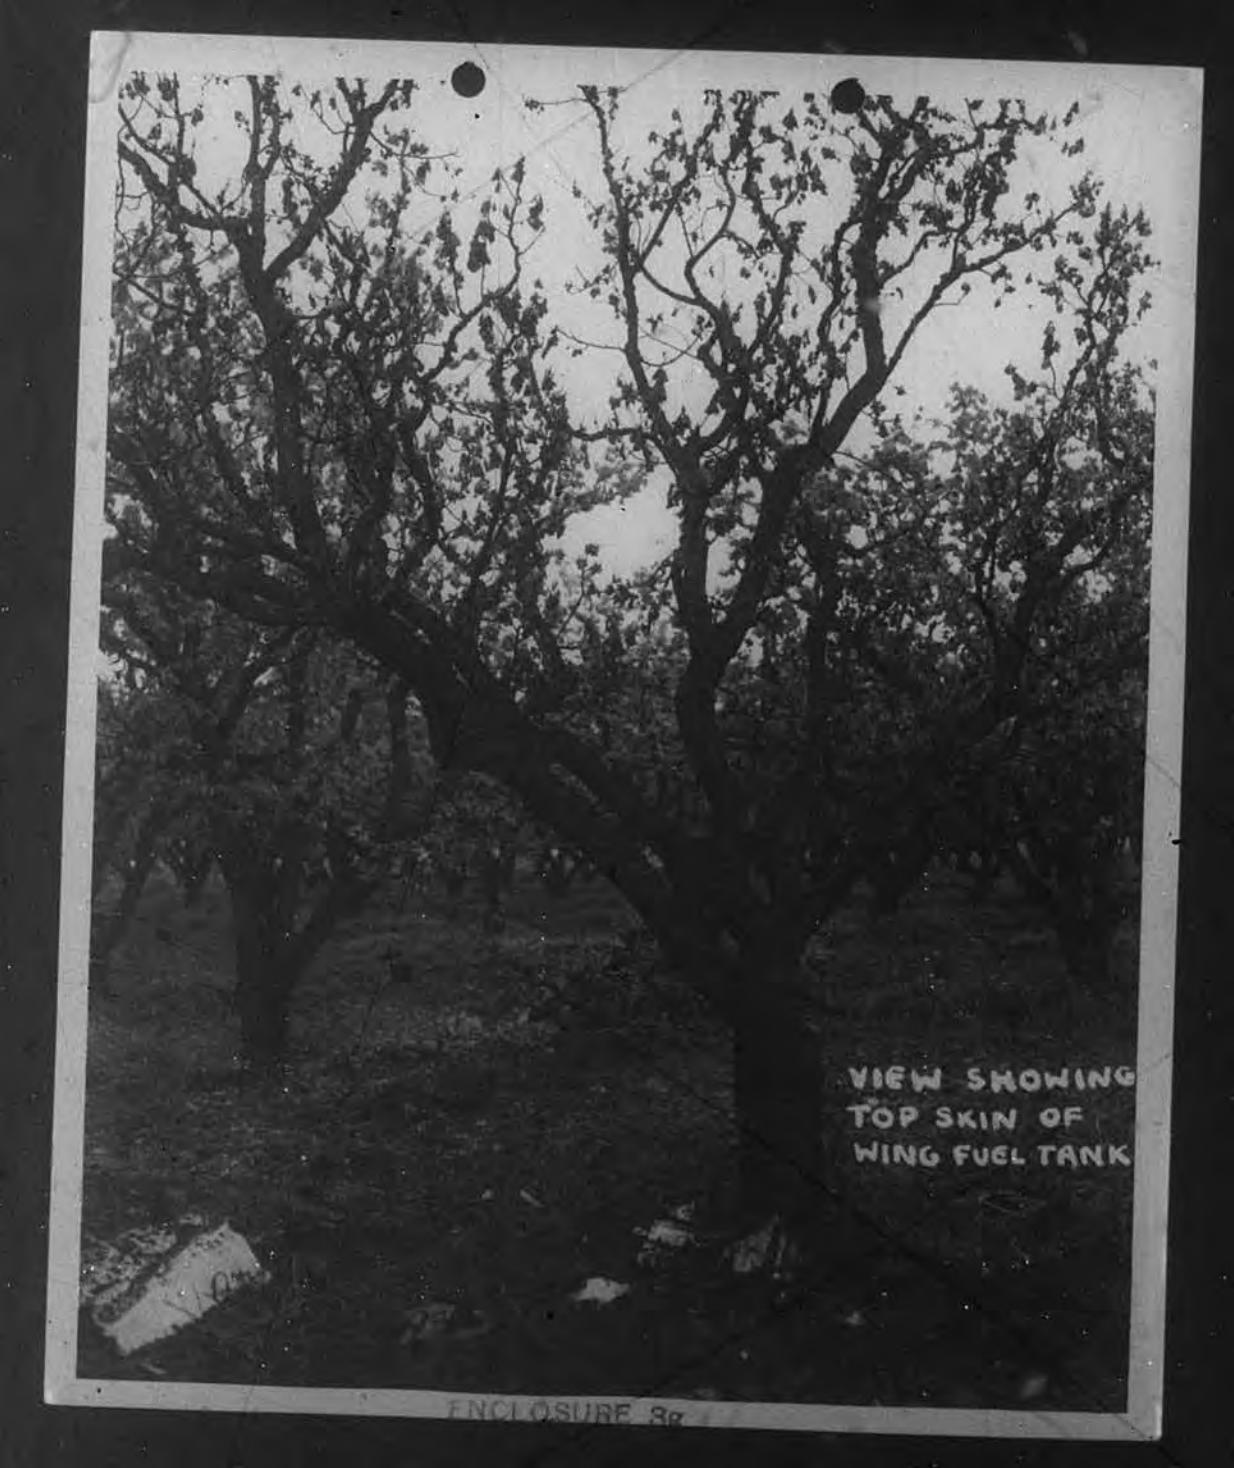
VIEW SHOWING  
TOP SKIN OF  
WING FUEL TANK

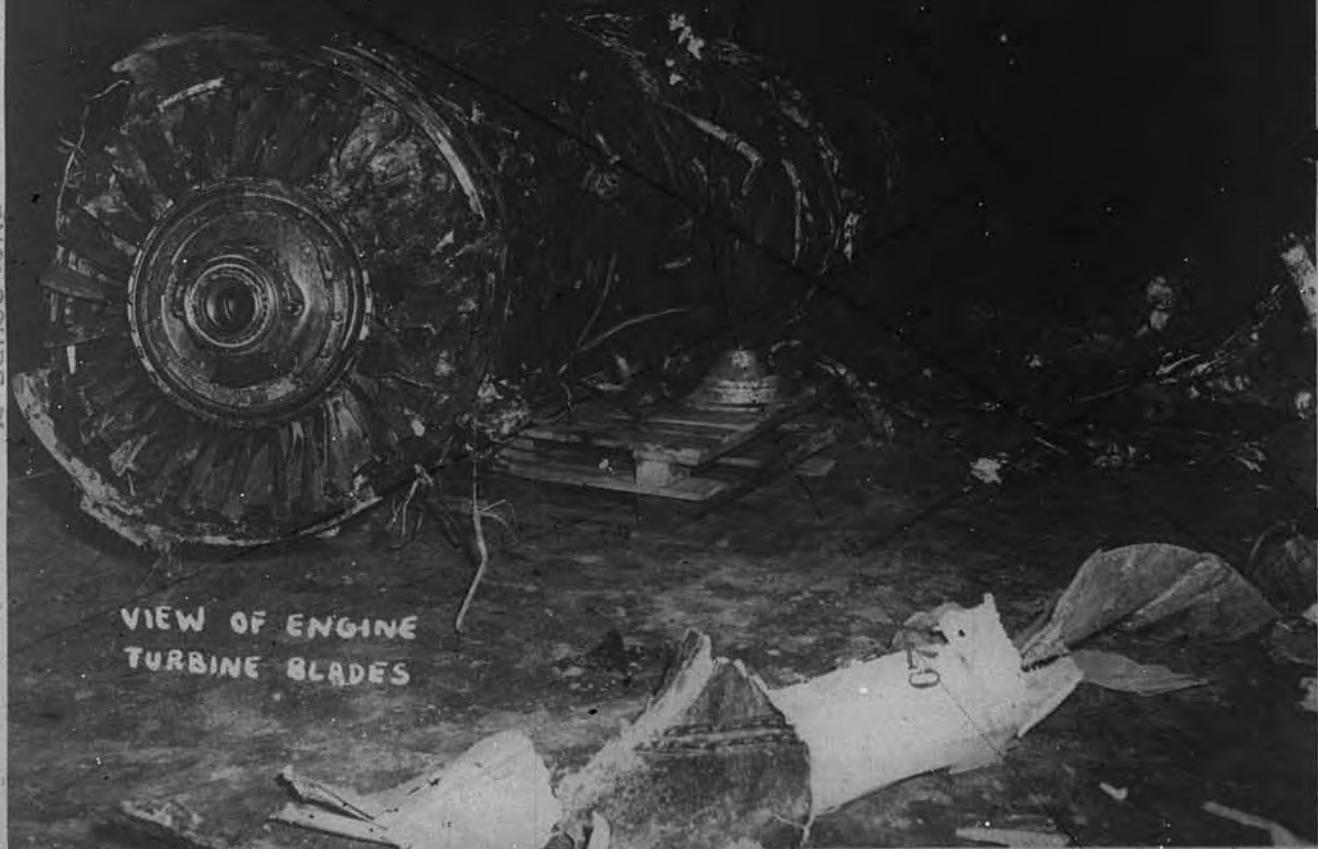
ENCLOSURE 3h

VIEW OF ENGINE  
TURBINE BLADES

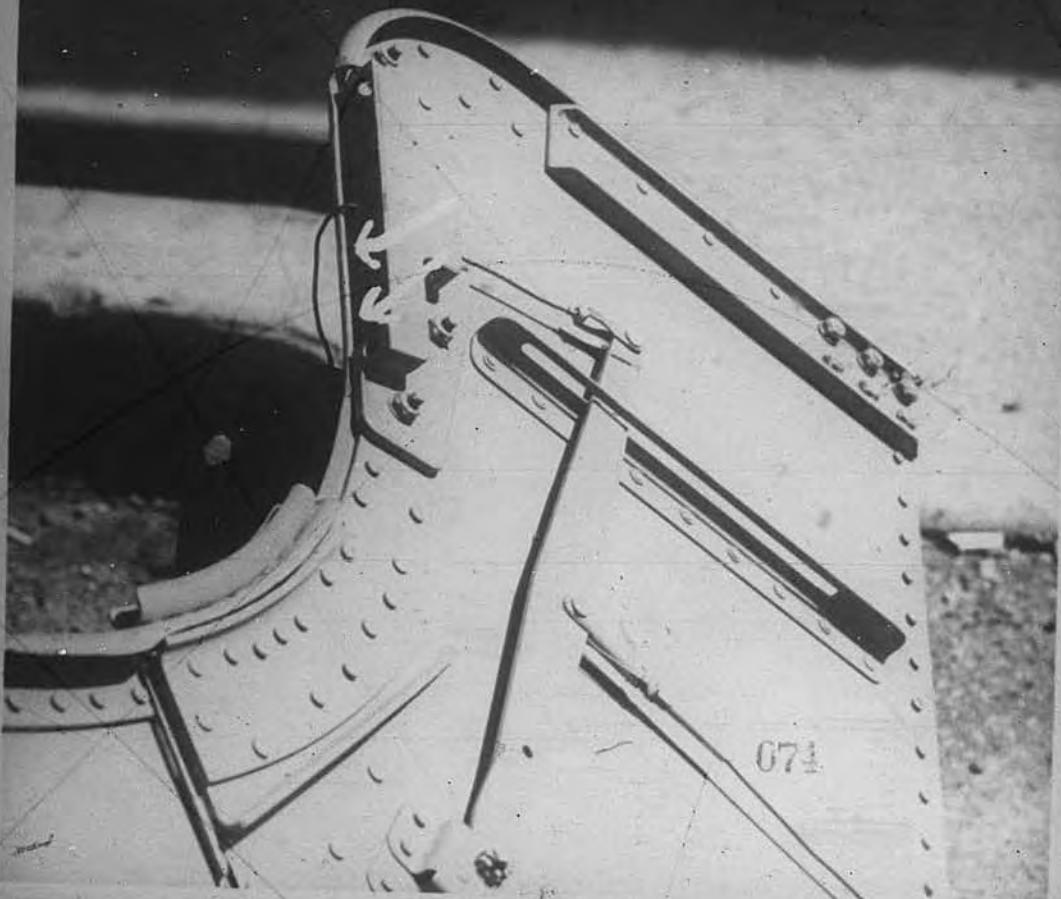
ENCLOSURE 8j

c. The rim of the seat (Enclosure 3j) showed scratches as could be caused by the abrasive forces of the cable at the crimp. No other portion of the seat showed such markings.

RIGHT SIDE OF EJECTION  
SEAT SHOWING KINKED  
EMERGENCY HARNESS  
RELEASE CABLE.

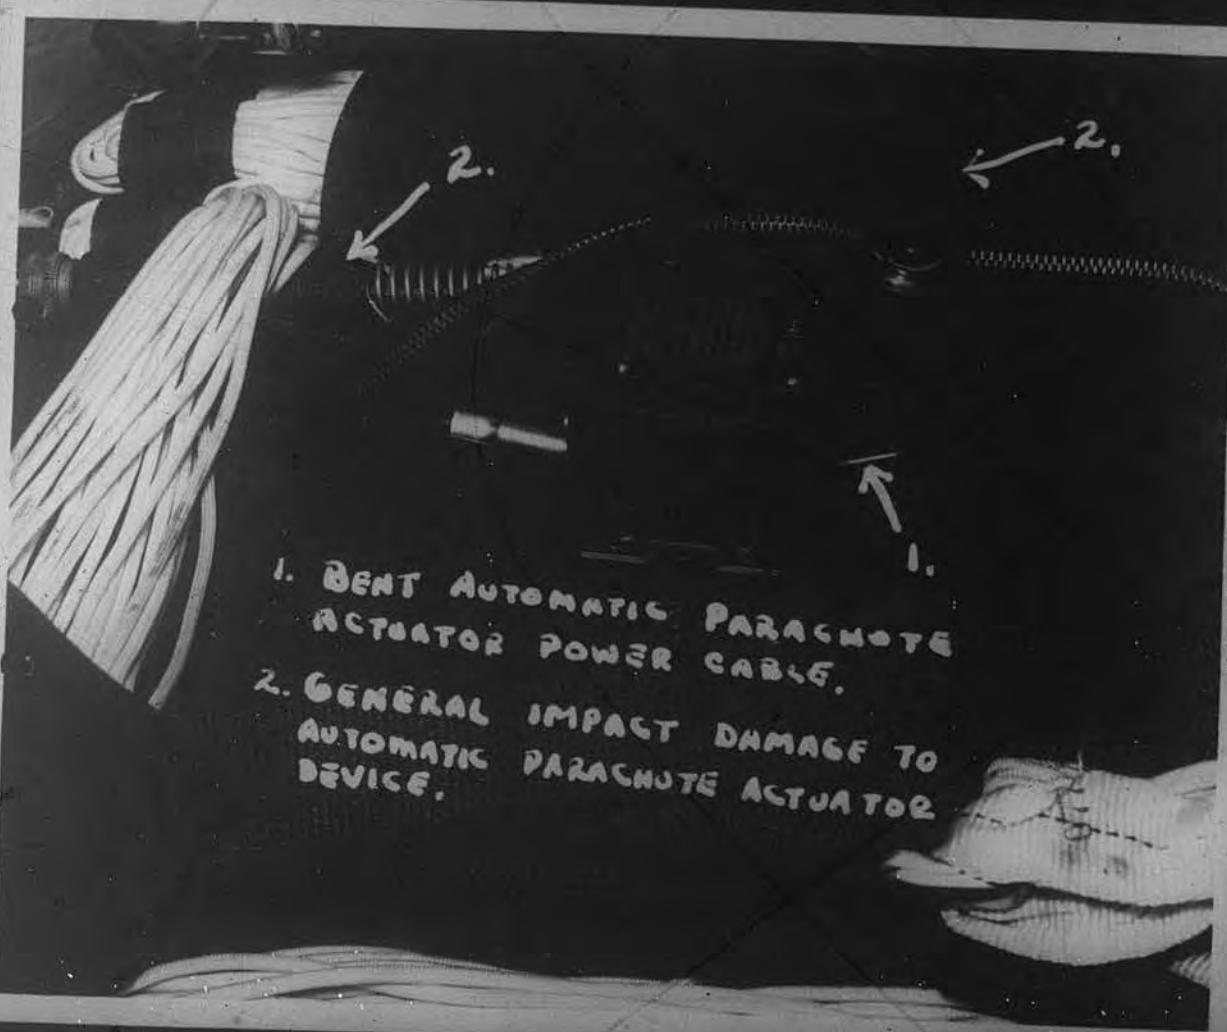
ENCLOSURE 3N

GENERAL IMPACT  
DAMAGED TO AUTOMATIC  
PARACHUTE ACTUATOR  
DEVICE.

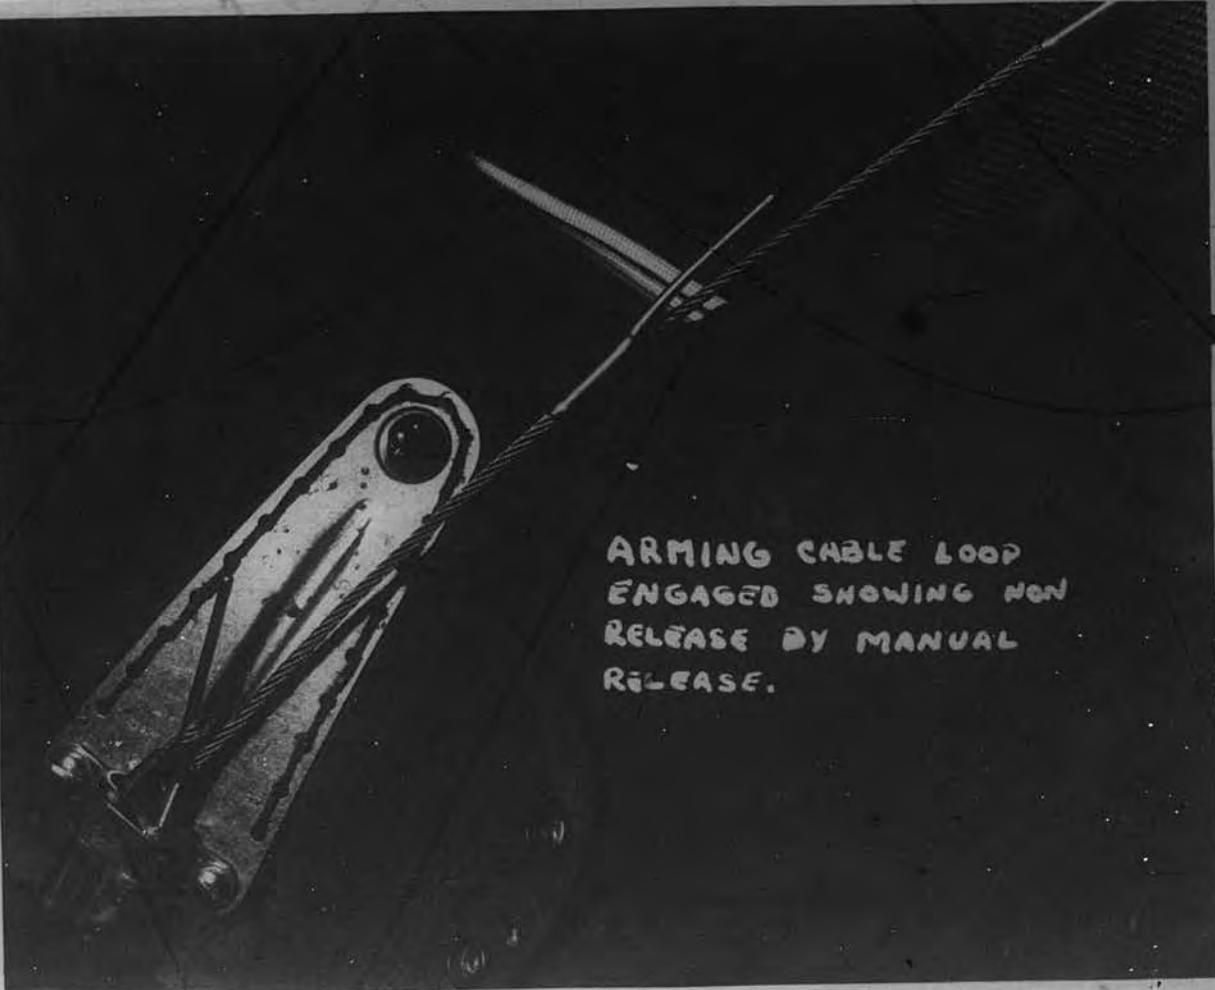
a. The loop end of the automatic power cable was found still attached around number one pin of the pin and cone assembly (Enclosure 3o). The loop is shown in the enclosure at the actuated position. This is because the power cable spring housing fractured and allowed the cable to retract the loop (Enclosure 3n). The pins are shown, therefore, in Enclosure 3o in a similar position as if the automatic feature of the chute had functioned. If the other release cable (manual) had been first pulled, the power cable loop would not be around the pin even though impact fracture allowed the power spring to retract the pins.

ARMING CABLE LOOP  
ENGAGED SHOWING NON  
RELEASE BY MANUAL  
RELEASE.

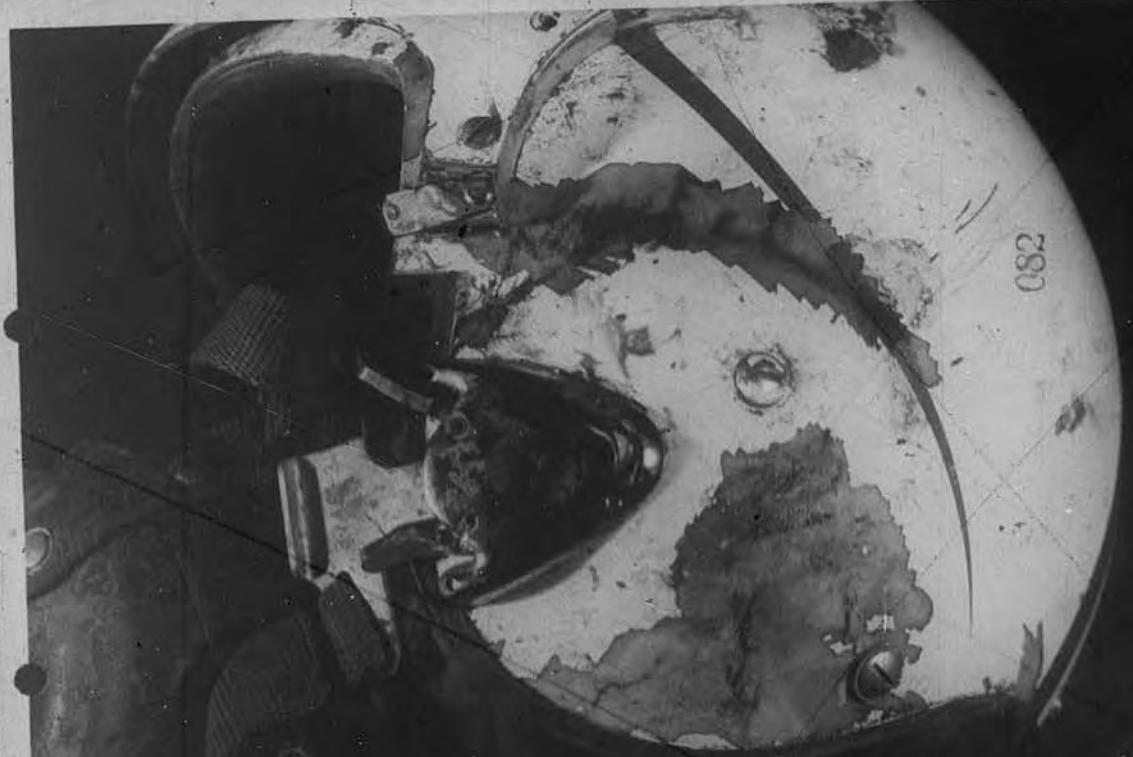
DAMAGED LEFT SIDE  
APH-5 HELMET.

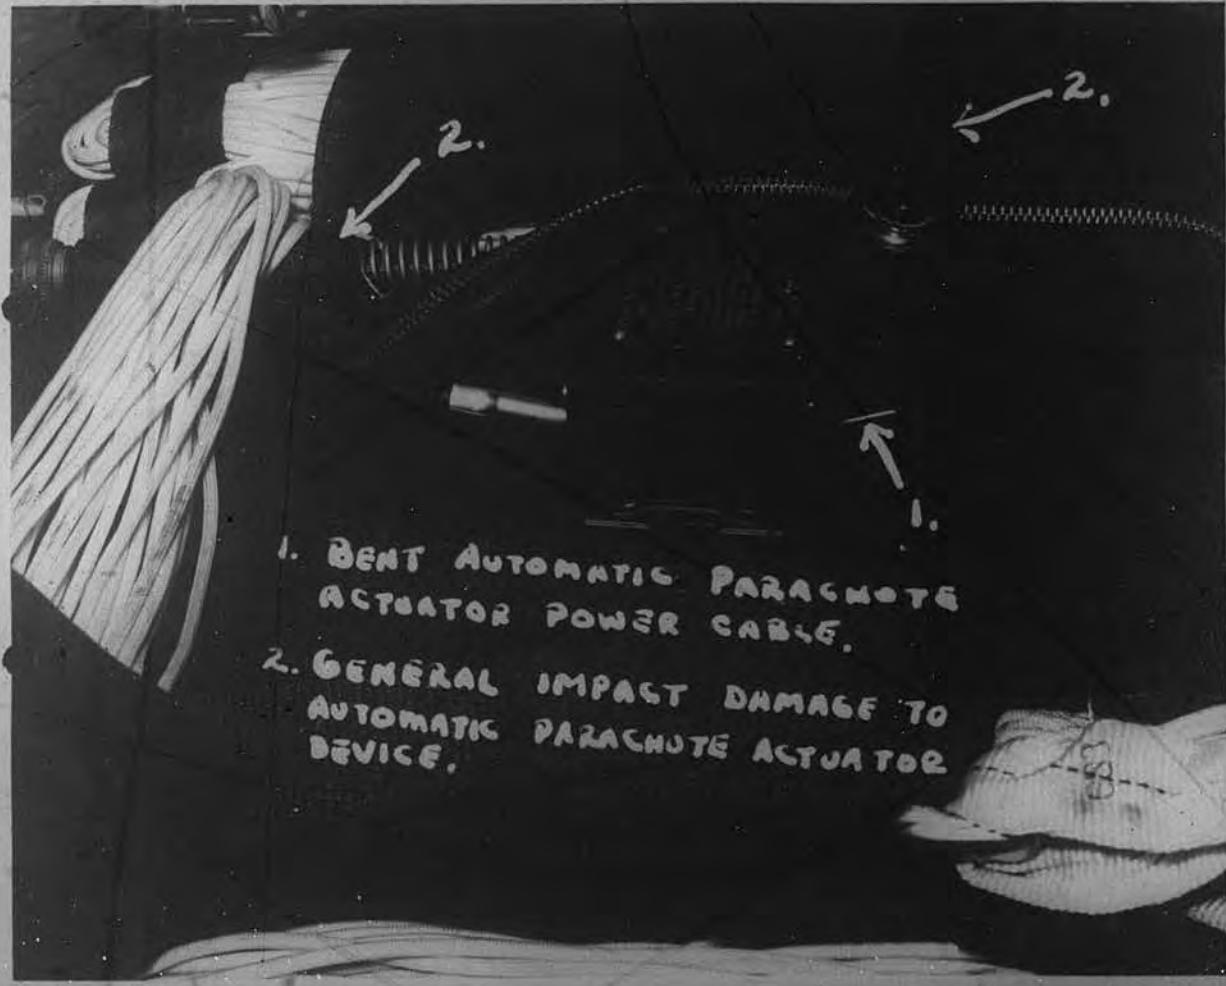
1. BENT AUTOMATIC PARACHUTE ACTUATOR POWER CABLE.
2. GENERAL IMPACT DAMAGE TO AUTOMATIC PARACHUTE ACTUATOR DEVICE.
